GEOTECHNICAL INVESTIGATION REPORT

**REPORT
ON TEST PIT INVESTIGATION
FOR REHABILITATION OF
EXIST LINK ROAD FROM KATHORE M9
TO NATIONAL HIGHWAY N5**

Client : Loya Associates
Project No. : CES-16655
Date : Feb 04, 2017

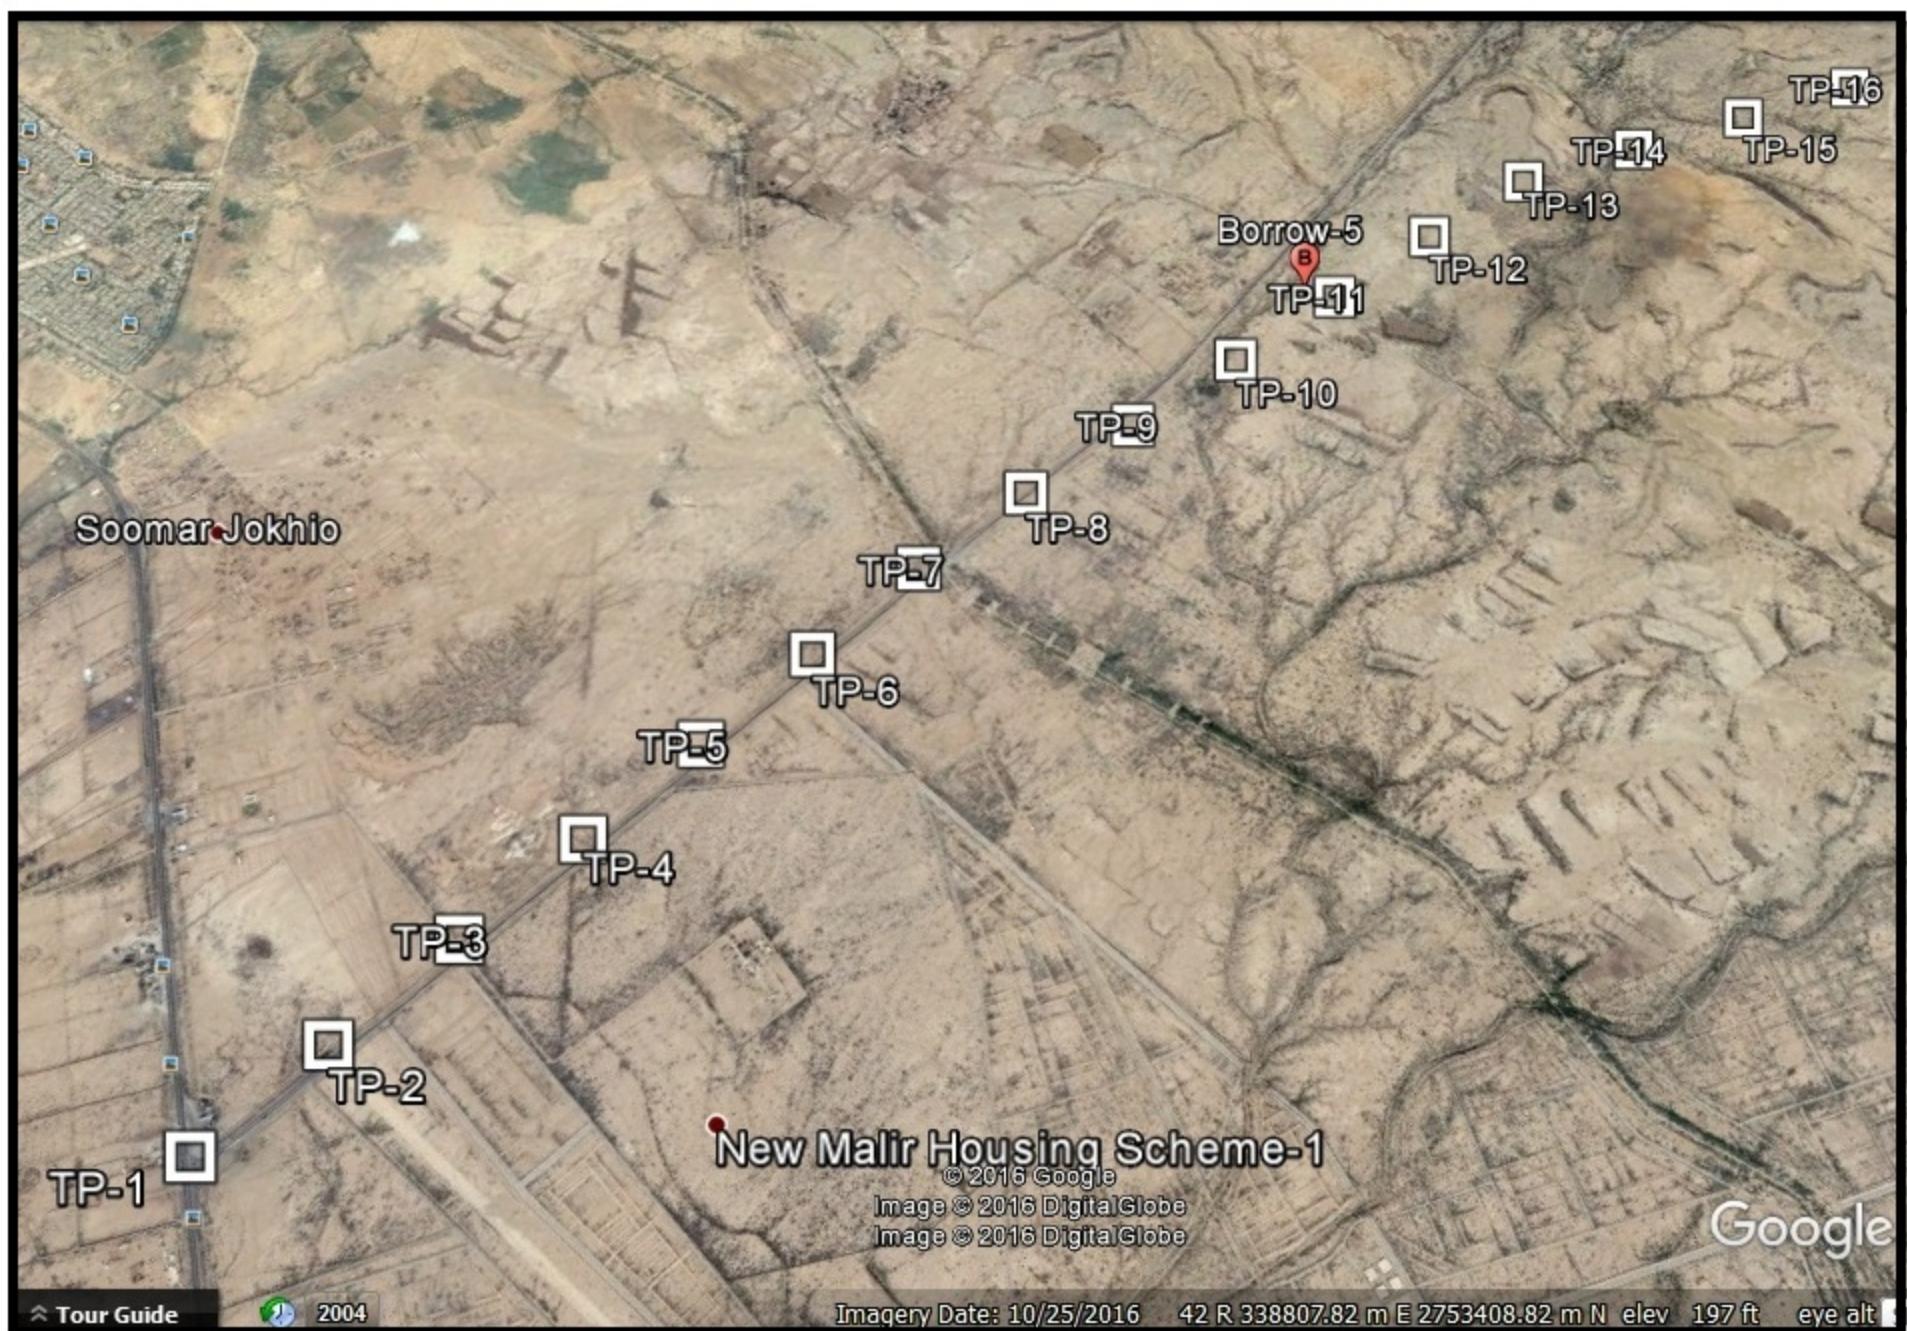
FIG-1: LOCATION OF TEST PITS

45 Pits and 5 Nos Borrow Pits were excavated upto 1.0m depth. The location of Test Pits shown in Fig-1.

FIG-1 LOCATION OF TEST PITS

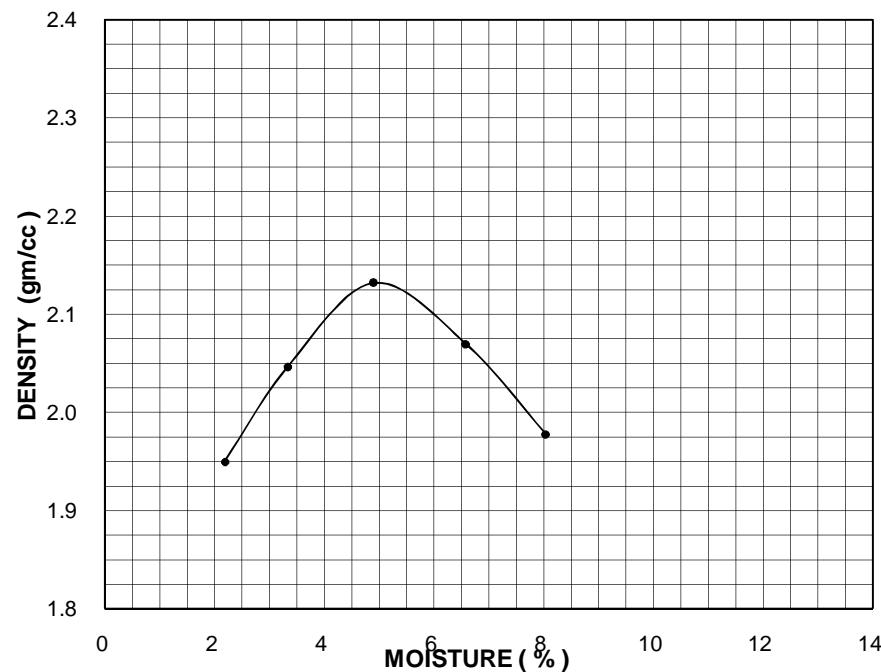
MODIFIED AASHTO COMPACTION

PIT No. : TP-38

AASHTO
CLASSIFICATION: A-1-a

O.M.C : 4.9 %

M.D.D : 2.132 gm/cc

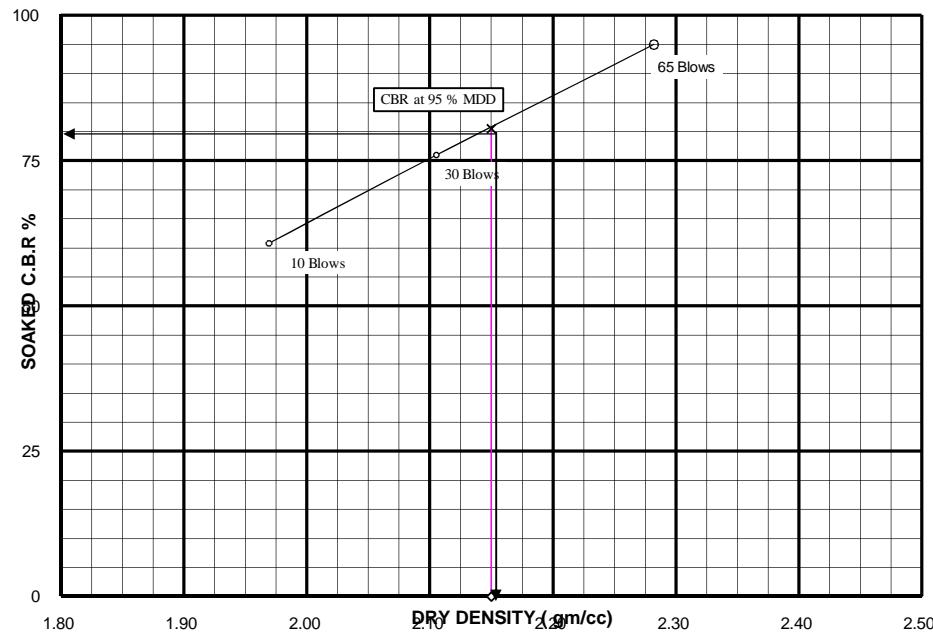
**THREE POINT C.B.R
DRY DENSITY VS CBR CURVE**

Blows	10	30	65
C.B.R %	61	76	95
Density gm/cc	1.969	2.105	2.282

PIT No. : TP-Borrow-02
SAMPLE : BS-1
DEPTH (ft m) : 0 - 1.0
AASHTO CLASSIFICATION: A-1-a
CBR at 95% MDD : 81 %
